Manhole Inspection Summary

Manhole # S19M__006MH

Insp Date: **2/24/08 9:29 AM**

Location Address: **401 s pulaski-s payson alley**

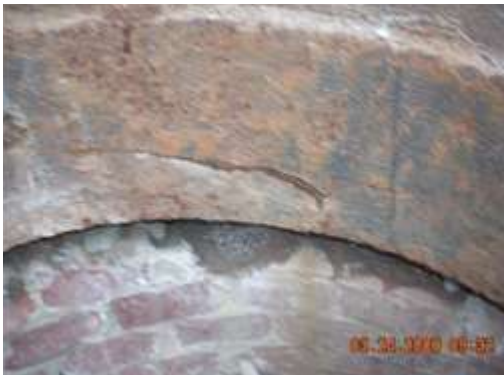
Defect 3

Frame Offset: **0** (in.) Condition: ☐ Sound ☒ **Cracked** ☐ Leaks

cracked frame

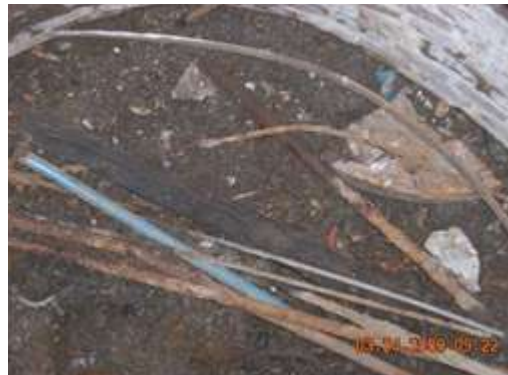
Defect 2

Condition: ☐ Sound ☐ Cracked ☐ Root Intrusion ☐ Deteriorated ☐ Leaks ☒ **Debris**

debris in the bottom of the terminal

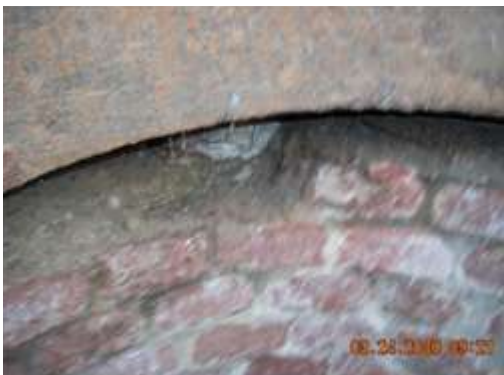
Defect 1

Condition: ☐ Sound ☐ Cracked ☐ Root Intrusion ☐ Loose Brick ☒ **Deteriorated**

deteriorated chimney

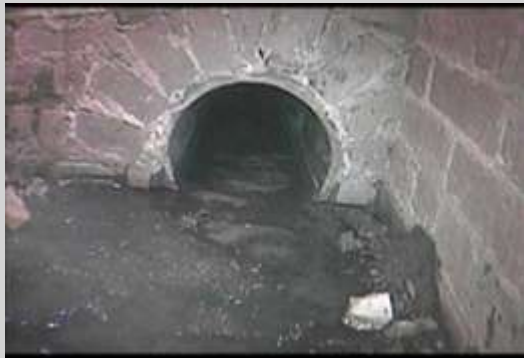
12 O'Clock Outflow

8 in. Circular Gravity Sewer
Pipe Out @ 12 O'Clock

Deposits: ☐ None ☒ **Mud** ☐ Sludge ☐ Debris ☐ Grease

Silt Depth: **2** (in.) Deposits Extent: **Light**
